# Manhole Inspection Summary

Manhole # S37AA1017MH

Insp Date: **1/3/07 9:54 AM**

**Location** Address: **707 34TH ST**

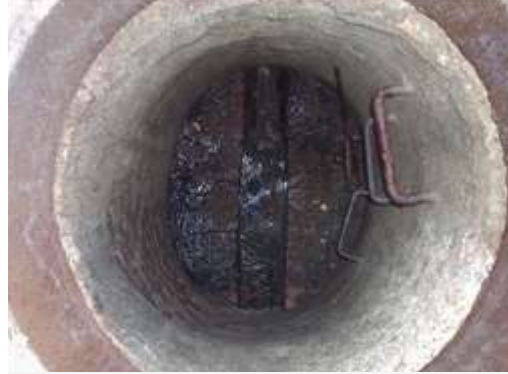
Top View

Corroded steps. Evidence of surcharge - Bench debris. Channel debris.

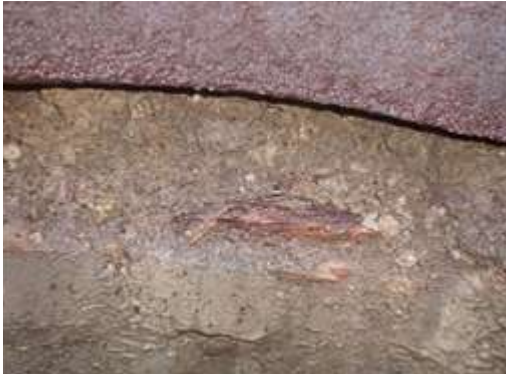
Defect

**Frame** Offset: **0** (in.) Condition: ☐ Sound ☐ Cracked ☒ **Leaks**

Condition: ☐ Sound ☐ Cracked ☐ Root Intrusion ☐ Loose Brick ☒ **Deteriorated**

Infiltration: ☐ None ☒ **Joint** ☐ Cracks ☐ Mortar ☐ Roots ☒ **Wall**

Frame leaks. Adjustment deterioration and infiltration.

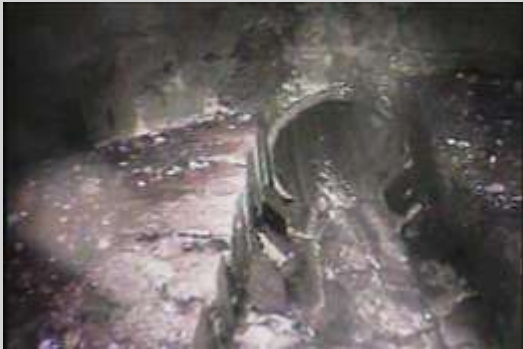
### 8 in. Circular Gravity Sewer Pipe Out @ 12 O'Clock

Infiltration: **Evidence** Pipe Seal Cond: **Unknown**

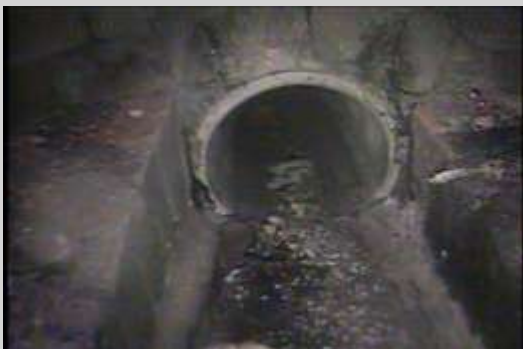
### 8 in. Circular Gravity Sewer Pipe In @ 6 O'Clock

Deposits: ☐ None ☒ **Mud** ☐ Sludge ☒ **Debris** ☐ Grease

Silt Depth: **0** (in.) Deposits Extent: **Light**

Infiltration: **None** Pipe Seal Cond: **Cracked**
